GEOTECHNICAL INVESTIGATION: REVISION 1
Cache Slough Mitigation Bank
SOLANO COUNTY, CALIFORNIA

Subject: GEOTECHNICAL INVESTIGATION: REVISION 1, CACHE SLOUGH
MITIGATION BANK, SOLANO COUNTY, CALIFORNIA

We performed a geotechnical investigation for the Cache Slough Mitigation Bank in Solano County, California in accordance with the proposal dated January 11, 2023. The results of the investigation are presented in the attached report.

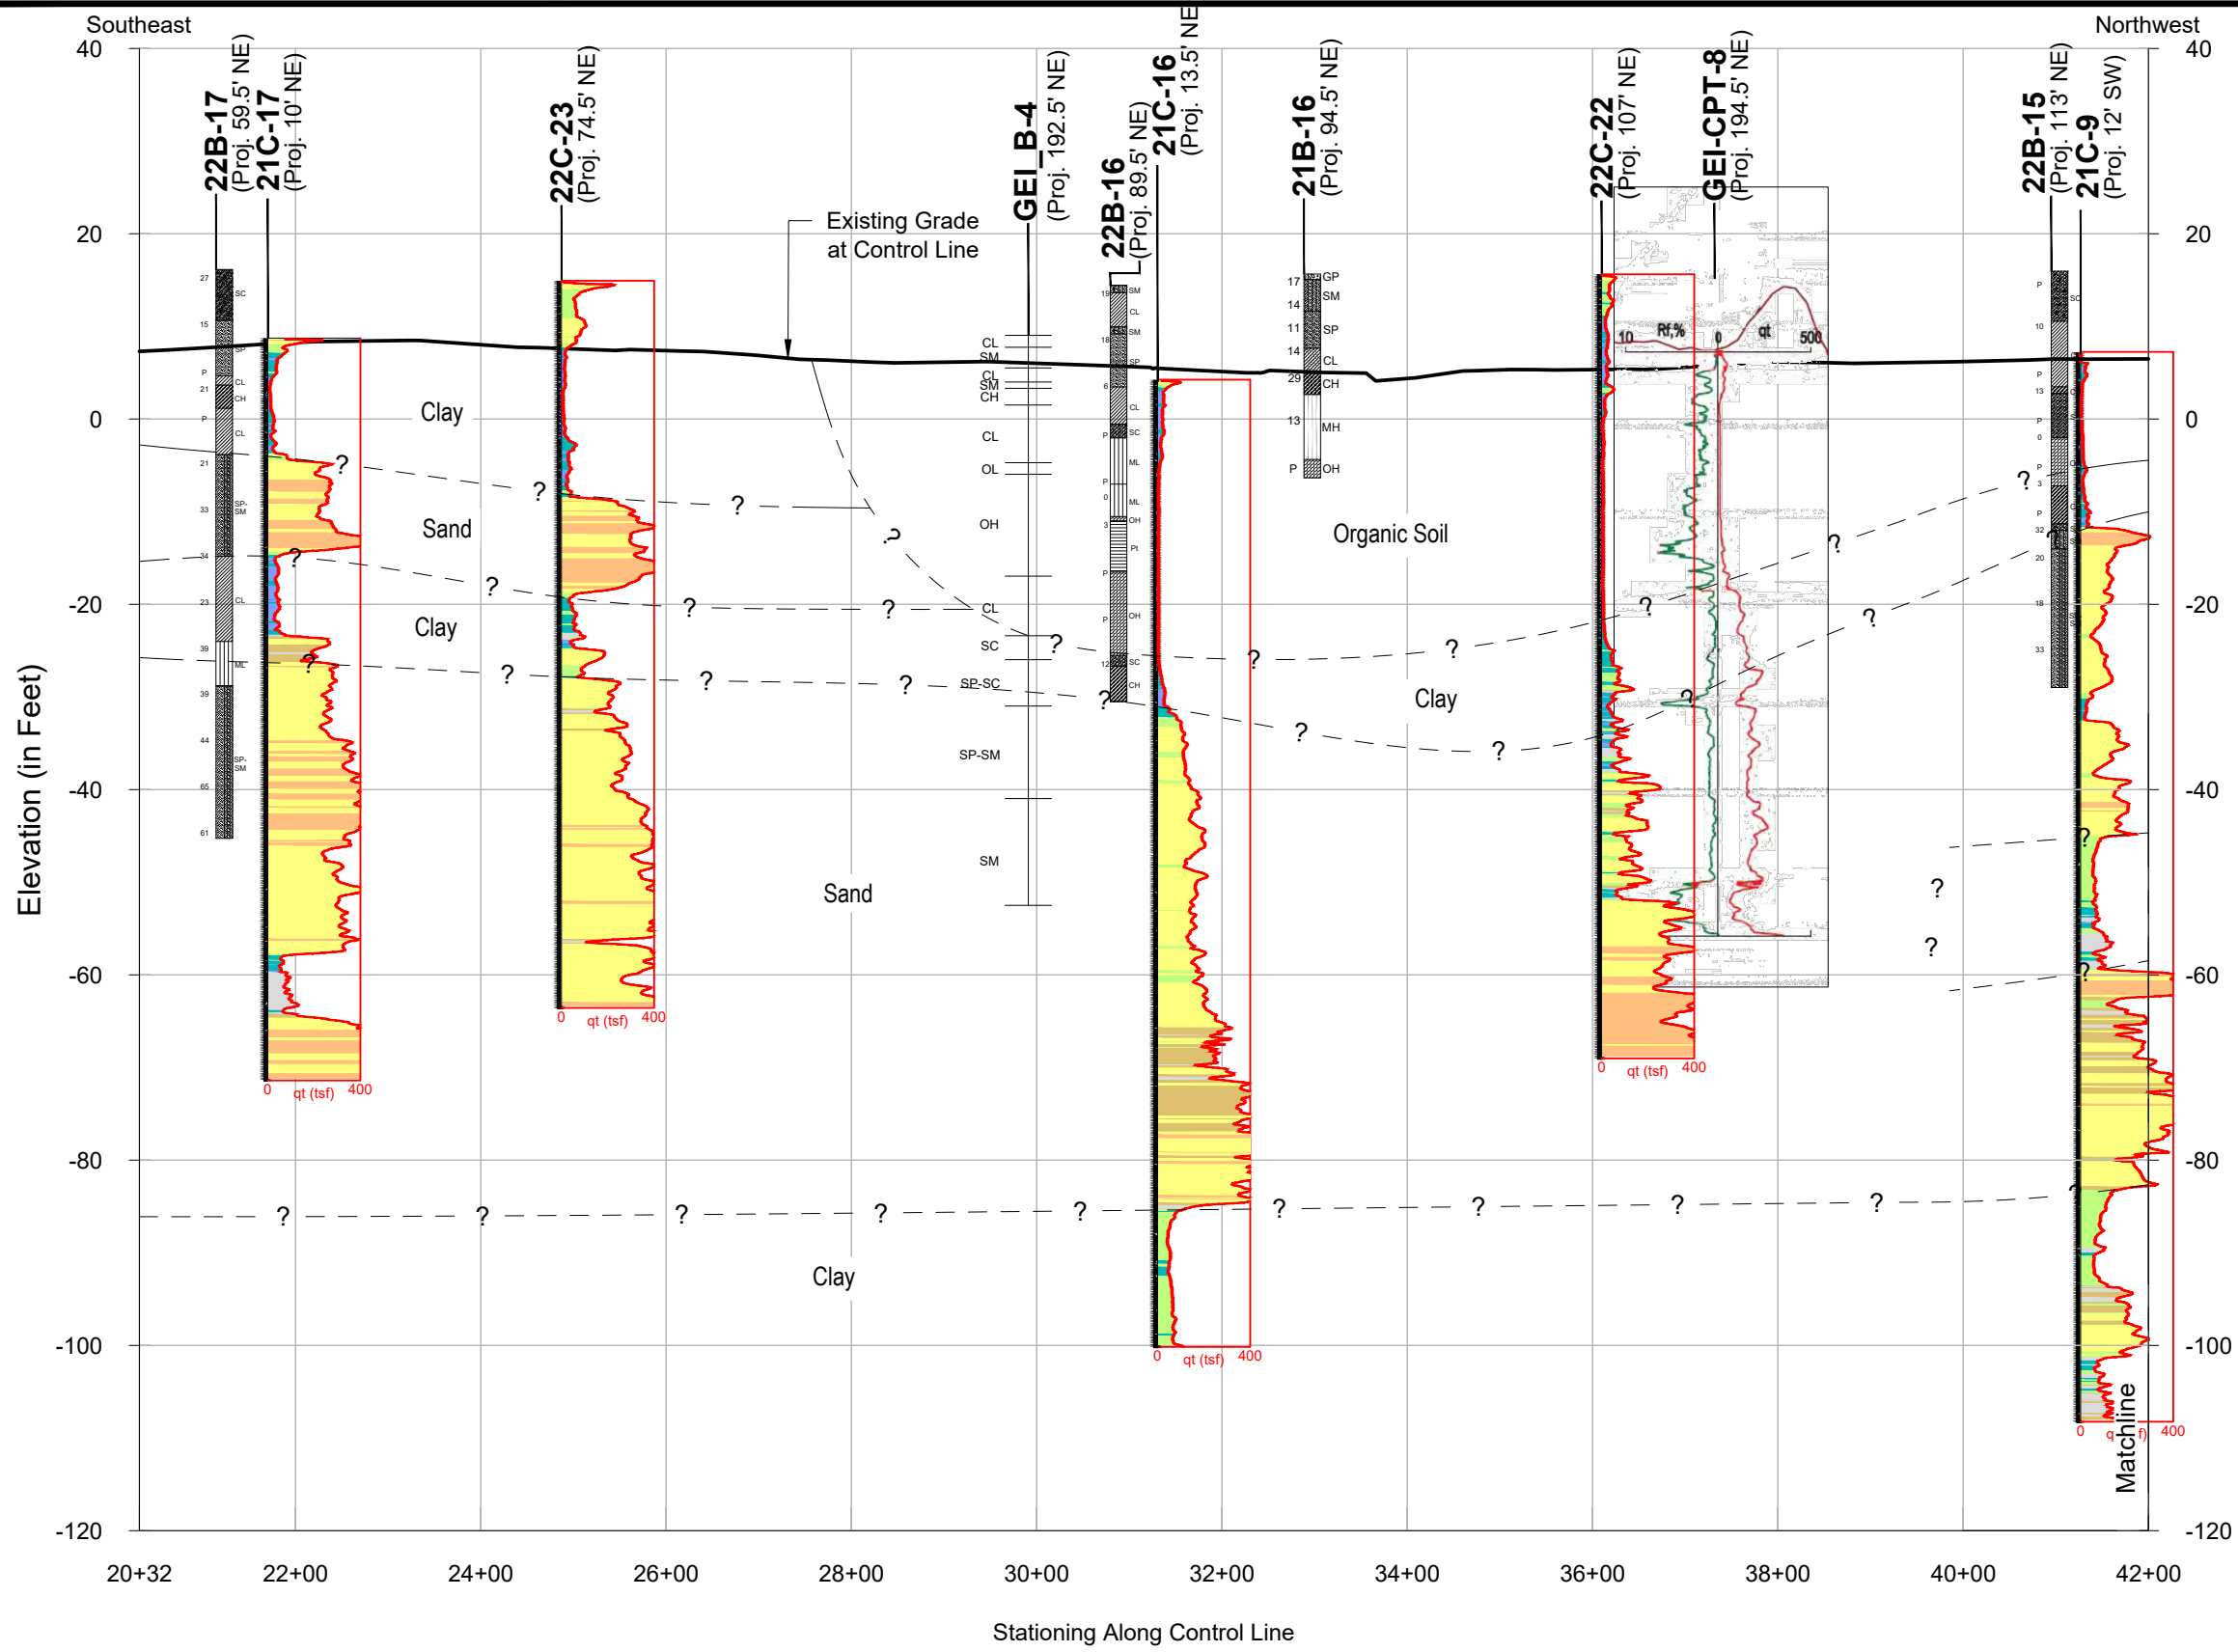
Cache Slough Mitigation Bank Solano County, California	
IDEALIZED GEOLOGIC PROFILE CACHE SLOUGH MITIGATION BANK STATION 20+32 to 42+00	
April 2024	110926
SHANNON & WILSON, INC. <small>GEOTECHNICAL AND ENVIRONMENTAL CONSULTANTS</small>	FIG. A-2

The subsurface conditions beneath the proposed perimeter berm are depicted in Appendix A. Idealized subsurface cross sections for seven stations along the alignment are presented in Appendix B.

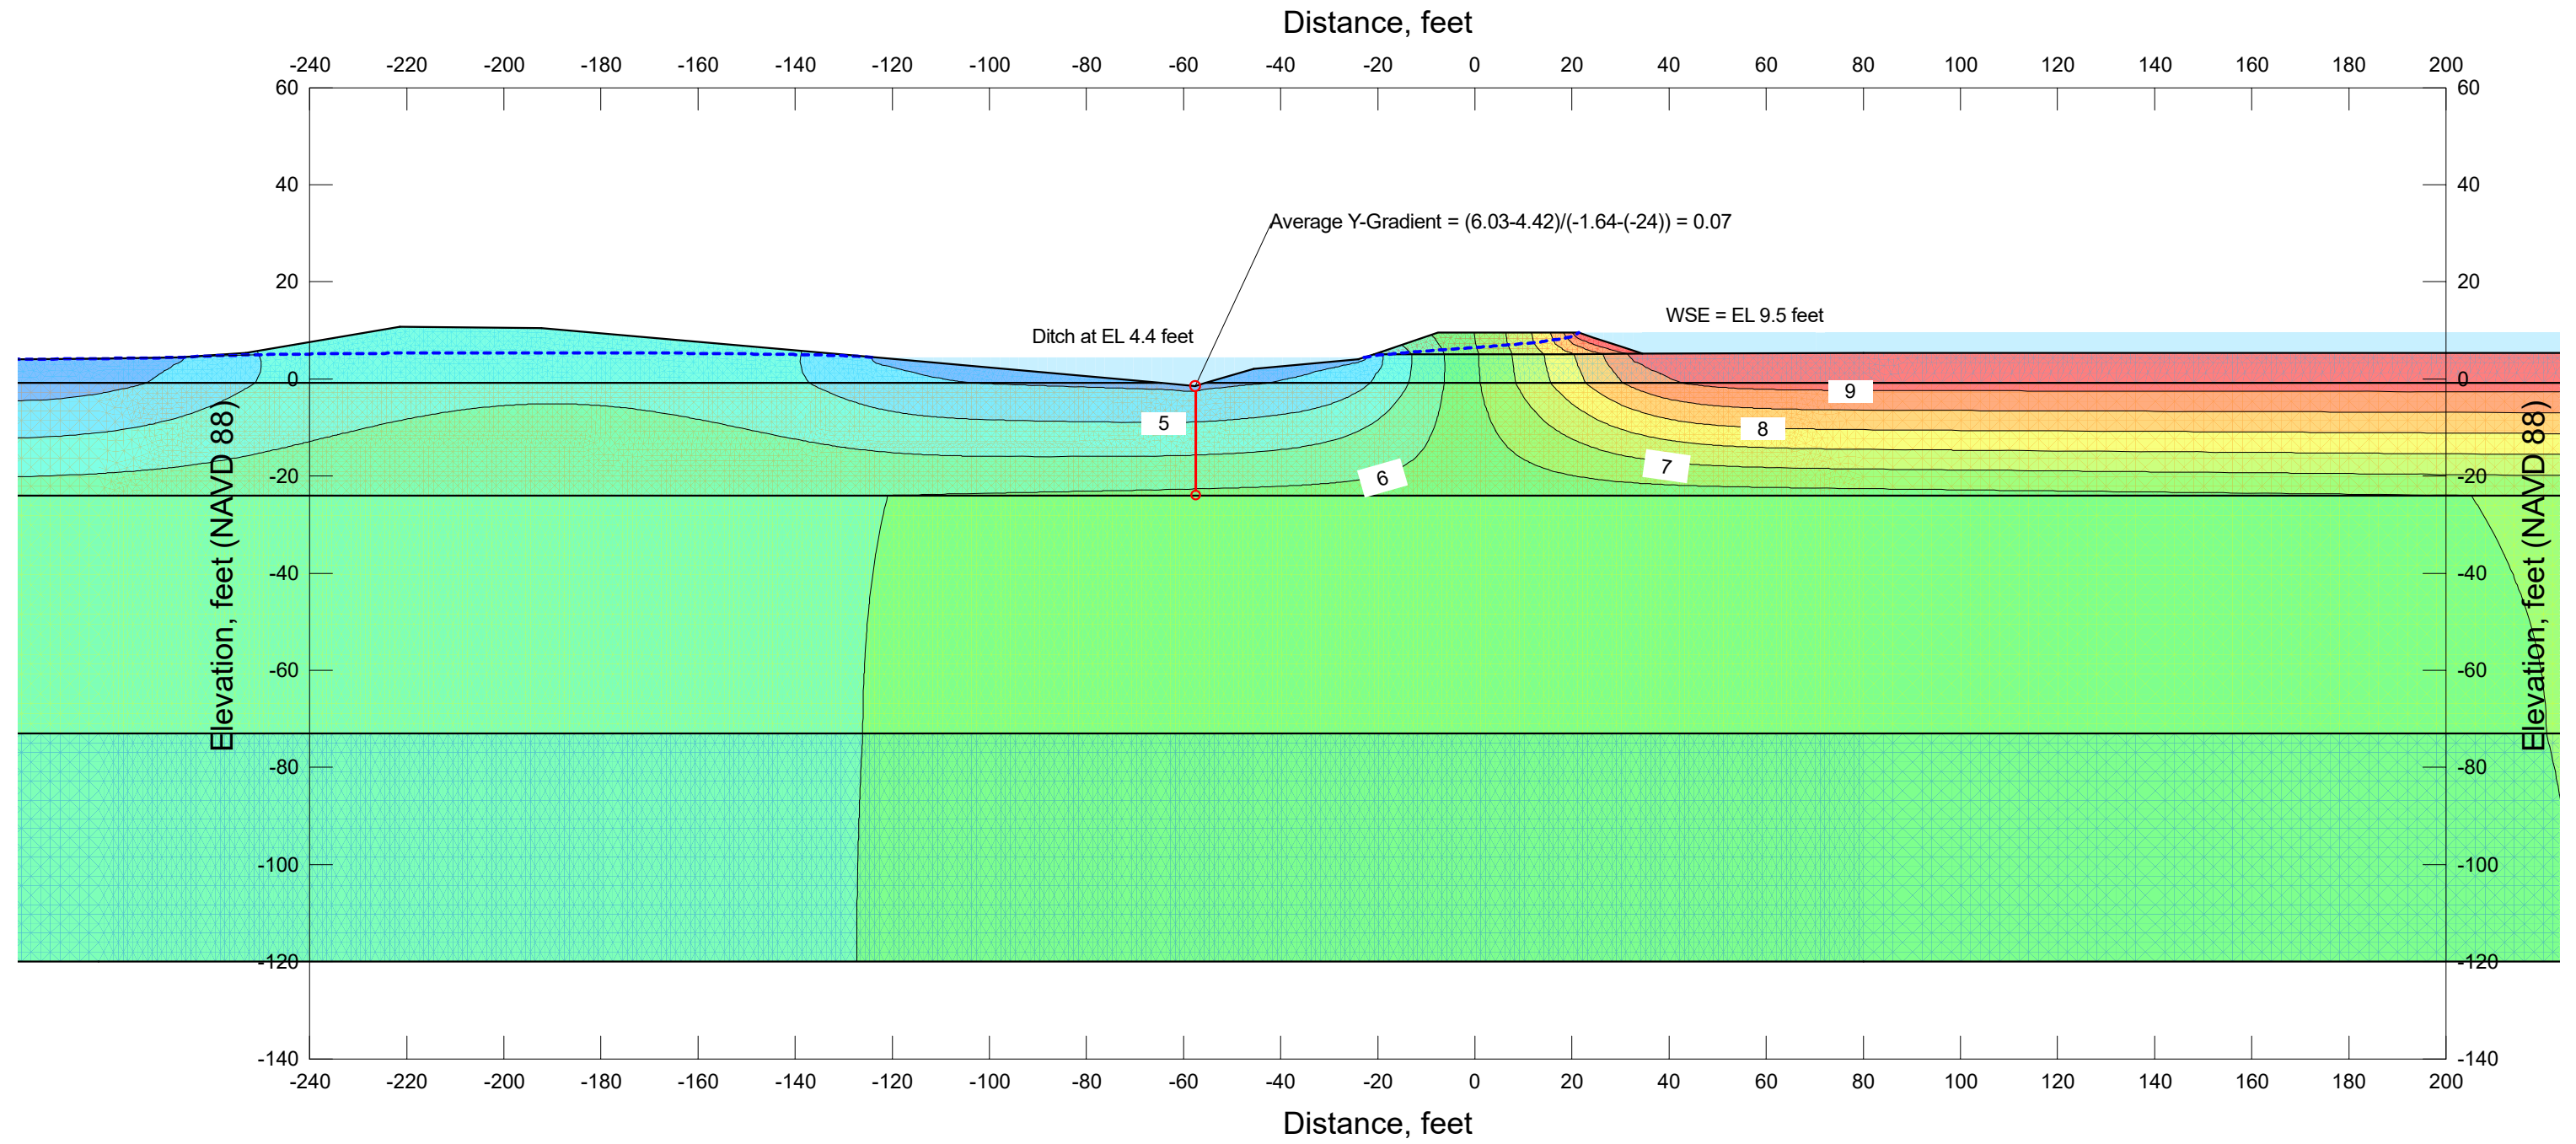
- Notes:
1. See Figure C-1 for material properties.
 2. Contours represent total head in feet of water.

Cache Slough Mitigation Bank Solano County, California	
Seepage Analysis Station 97+32 Steady State Conditions	
April 2024	110926
SHANNON & WILSON, INC. Geotechnical and Environmental Consultants	FIG. C-11

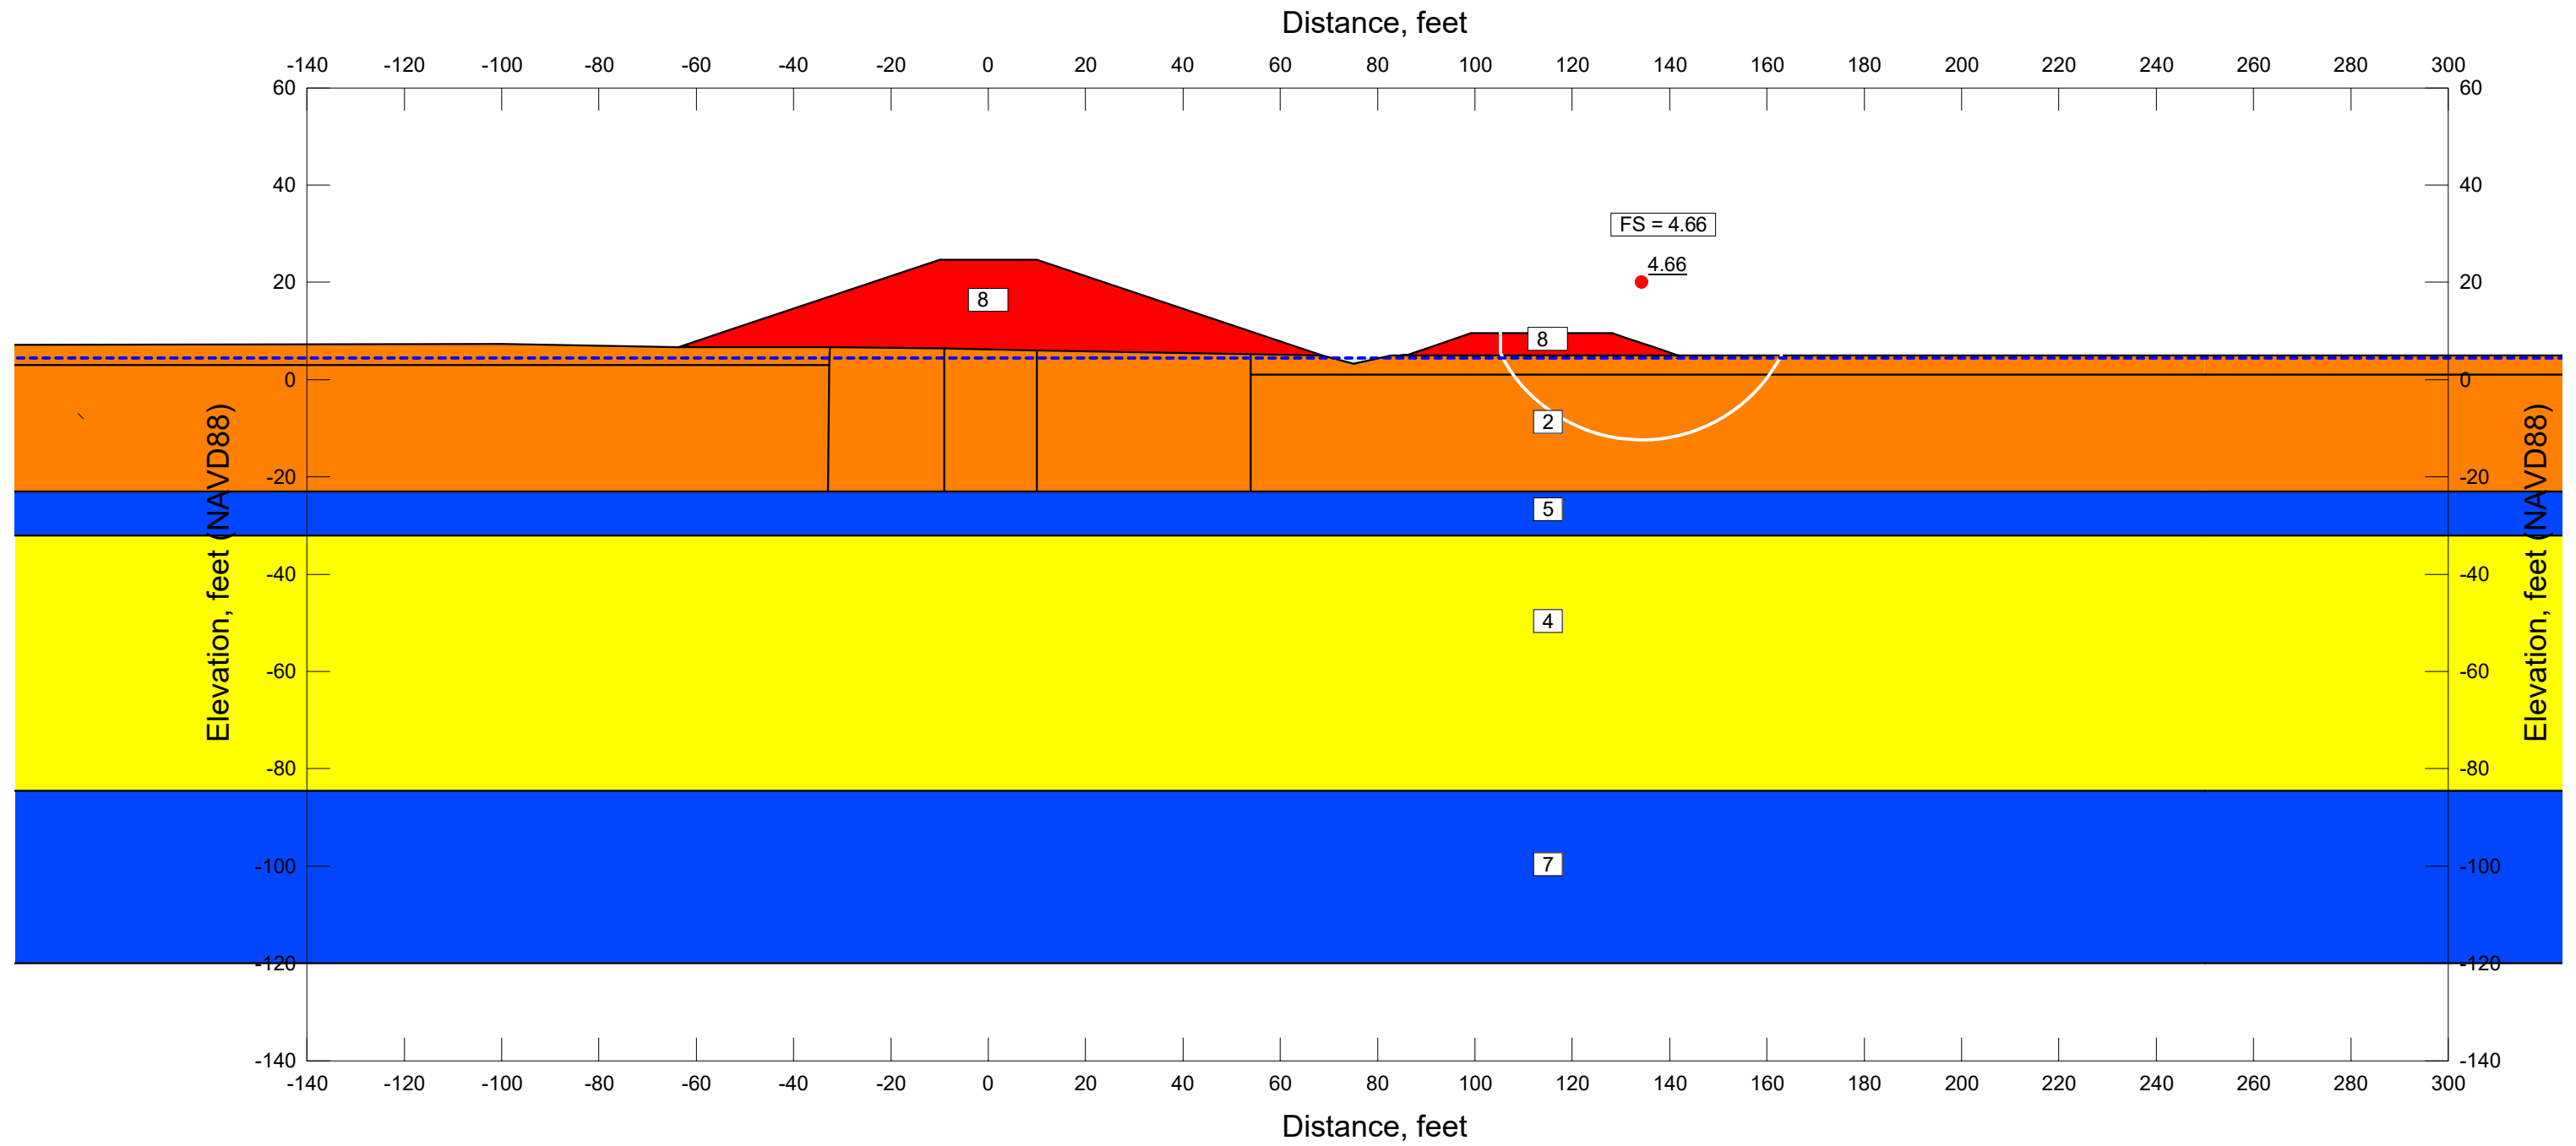
Cache Slough Mitigation Bank Solano County, California	
Slope Stability Analysis Station 36+32 End-of-Construction - Waterside	
April 2024	110926
SHANNON & WILSON, INC. Geotechnical and Environmental Consultants	FIG. D-7

Notes:
 1. See Figure D-1 for material properties.

We performed analysis to check the factors of safety for the landside and waterside slopes for steady state seepage and rapid drawdown loading conditions before and after the levee rehabilitation. We also analyzed the factor of safety for the landside and waterside slopes for the end-of-construction condition. The stability analysis was performed on the same cross sections that were analyzed for seepage. We used the computer program SLOPE/W and Spencer's method of analysis. We used effective stress strength parameters for analyzing the factors of safety under steady-state seepage conditions. We analyzed the stability of the landslide slope for steady state seepage conditions by importing pore water pressures calculated in the seepage analysis using the waterside water level at Elevation 9.5. We analyzed the stability of the waterside slope for rapid drawdown using the waterside water level at Elevation 9.5. For the rapid drawdown analysis, we used the feature in SLOPE/W that used the Staged Rapid Drawdown Analysis option based on the Duncan et al., 1990 procedure and both the effective stress and undrained strength envelopes. For the end-of-construction analysis we used undrained strength parameters. We modeled a tension crack through the levee fill for the end-of-construction case.
